**Flood Control Project Maintenance  
Levee Inspections**

**Fall 2016 Levee Maintenance Deficiency Summary Report**

**Reclamation District No. 2035 Conaway**

**Levee Inspection Report By Mile - Fall 2016**

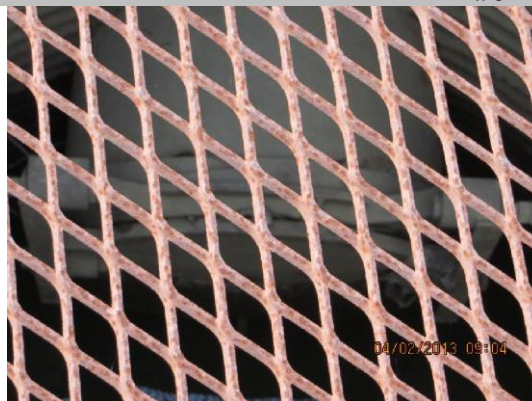
Photo 1 of 2 : UCIP\_FA\_2016\_41346\_18102.jpg

LM Start	0.00	Rating **	M	Issue No.	15
LM End	0.00	Issue Type +	En	Location *	CR
Category	Supplemental			GPS Latitude/Longitude	
				Start	End
Item	DWR UCIP Field Study			38.677393 °	38.677393 °
				-121.709890 °	-121.709890 °
DWR ID					
Comment Code					
Inspector Comment					
FS_ID:41346 DS_ID:17819 EP_NO: 4363 Repair Type: Non-Urgent Crossing Status: Found UCIP Comments: This pipe appears abandoned and if so should be done so properly. FIELD_STRUCT_DESC: *ABANDONED* 36-inch Corrugated Metal Pipe through levee 7.8 feet below crown. Flap gate in 72-inch CMP riser at WS toe with abandoned pump platform on south side of East Main Street. A 30-inch welded steel pipe is sleeved through the 36-inch C.M. pipe and annular space grouted. (Permit No. 4363 - City of Woodland) FS Date: 4/2/2013 3:09:00 PM

Flap gate and pipe at bottom of 72-inch CMP riser on WS toe.

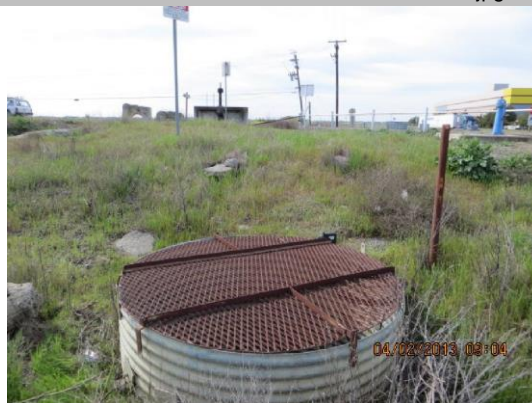
Photo 2 of 2 : UCIP\_FA\_2016\_41346\_18101.jpg

72-inch CMP riser on WS toe.

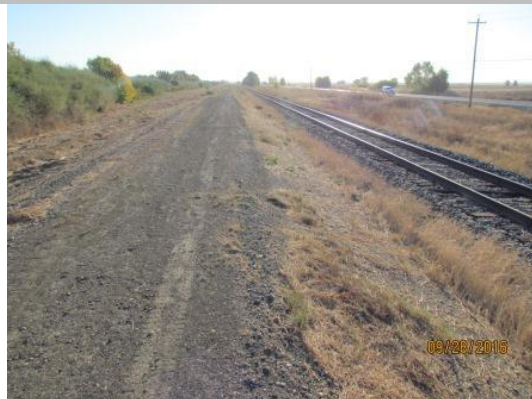
Photo 1 of 1 : FA\_2016\_RD2035\_238\_12\_20160929\_00014.jpg

LM Start	0.03	Rating **	A	Issue No.	12
LM End	2.00	Issue Type +	Ma	Location *	LS
Category	Earthen Levee			GPS Latitude/Longitude	
				Start	End
Item	Vegetation			38.677382 °	38.677180 °
				-121.709318 °	-121.672847 °
DWR ID	DWR_RD2035_01_f_2016_12				
Comment Code					
V1 : Control annual grass and weeds on the levee slopes and easements.					
Inspector Comment					
The Levee has no unwanted vegetation blocking visibility or access; vegetation is very well maintained.

View of the maintained annual vegetation on the landside looking downstream. Fall 2016.

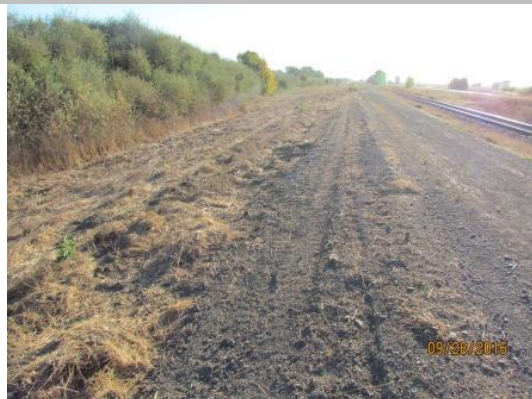
Photo 1 of 1 : FA\_2016\_RD2035\_238\_8\_20160929\_00015.jpg

LM Start	0.03	Rating **	A	Issue No.	8
LM End	2.00	Issue Type +	Ma	Location *	WS
Category	Earthen Levee			GPS Latitude/Longitude	
				Start	End
Item	Vegetation			38.677381 °	38.677180 °
				-121.709316 °	-121.672847 °
DWR ID	DWR_RD2035_01_f_2016_8				
Comment Code					
V1 : Control annual grass and weeds on the levee slopes and easements.					
Inspector Comment					
The Levee has no unwanted vegetation blocking visibility or access; vegetation is very well maintained.

View of the maintained annual vegetation on the waterside looking downstream. Fall 2016.

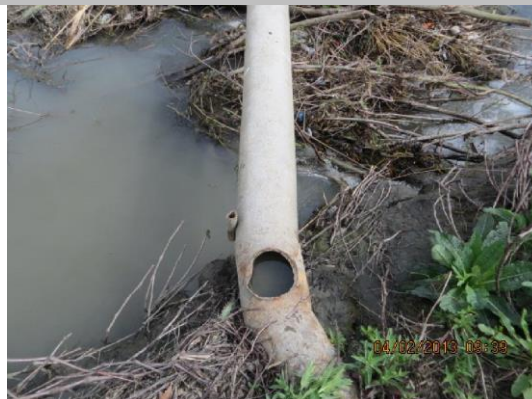
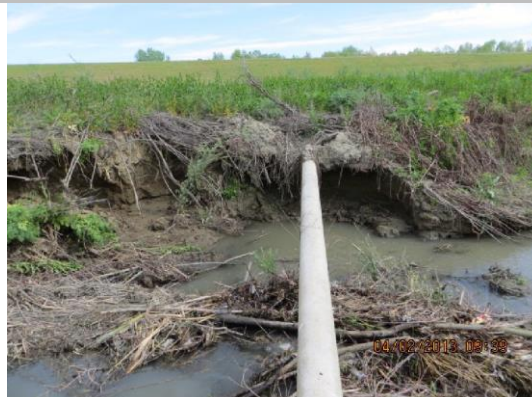
LM Start	1.27	Rating **	M	Issue No.	16
LM End	1.27	Issue Type +	En	Location *	CR
Category	Supplemental			GPS Latitude/Longitude	
				Start	End
Item	DWR UCIP Field Study			38.677249 °	38.677249 °
				-121.686358 °	-121.686358 °
DWR ID					
Comment Code					
Inspector Comment					
FS_ID:42012 DS_ID:17816 EP_NO: 12597 Repair Type: Non-Urgent Crossing Status: Found UCIP Comments: Pipe appears abandoned and if so should be done so properly. FIELD_STRUCT_DESC: *ABANDONED* 18-inch steel conductor pipe for flooding silt dredge through the levee 3.4 feet below the crown. 10-inch steel pipe sleeved through the 18-inch steel conductor pipe annular space grouted. Siphon breaker on waterward shoulder in steel riser. (Permit No. 12597 - R.D. No. 2035) FS Date: 4/2/2013

Exposed pipe at WS toe/stream.

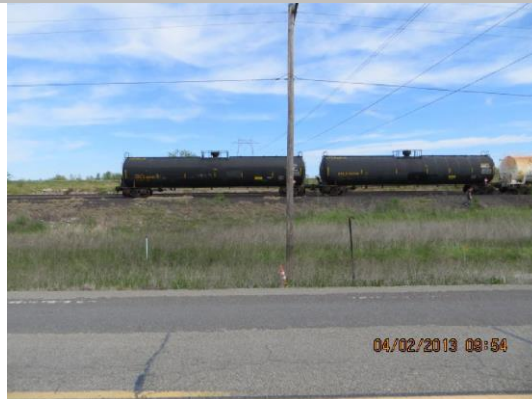
Photo 2 of 2 : UCIP\_FA\_2016\_10913\_18187.jpg

Vent pipe to right of JP next to Old River Road.

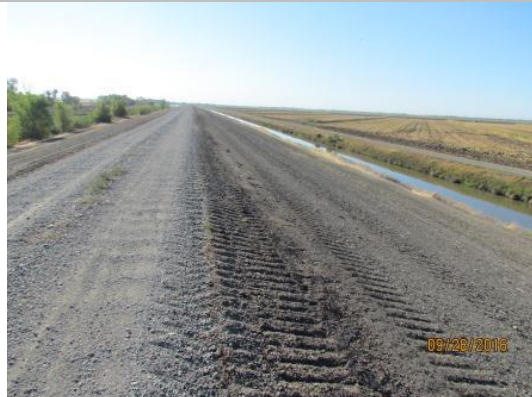
Photo 1 of 1 : FA\_2016\_RD2035\_239\_15\_20160929\_00025.jpg

LM Start	0.05	Rating **	A	Issue No.	15
LM End	7.62	Issue Type +	Ma	Location *	LS
Category	Earthen Levee			GPS Latitude/Longitude	
				Start	End
Item	Vegetation			38.676413 °	38.575386 °
				-121.672497 °	-121.635464 °
DWR ID	DWR_RD2035_02_f_2016_15				
Comment Code					
V1 : Control annual grass and weeds on the levee slopes and easements.					
Inspector Comment					
The Levee has no unwanted vegetation blocking visibility or access; vegetation is very well maintained.

View of the maintained annual vegetation on the landside looking downstream. Fall 2016.

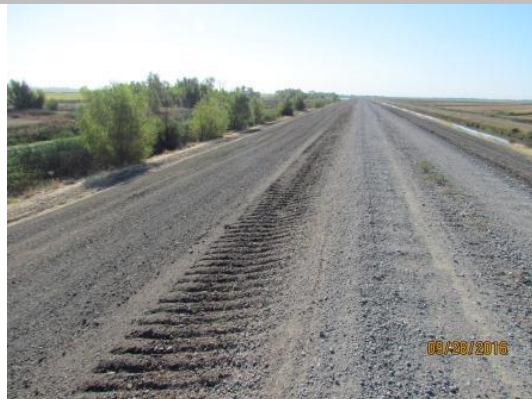
Photo 1 of 1 : FA\_2016\_RD2035\_239\_20\_20160929\_00024.jpg

LM Start	0.05	Rating **	A	Issue No.	20
LM End	7.62	Issue Type +	Ma	Location *	WS
Category	Earthen Levee			GPS Latitude/Longitude	
				Start	End
Item	Vegetation			38.676413 °	38.575386 °
				-121.672497 °	-121.635464 °
DWR ID	DWR_RD2035_02_f_2016_20				
Comment Code					
V1 : Control annual grass and weeds on the levee slopes and easements.					
Inspector Comment					
The Levee has no unwanted vegetation blocking visibility or access; vegetation is very well maintained.

View of the maintained annual vegetation on the waterside looking downstream. Fall 2016.

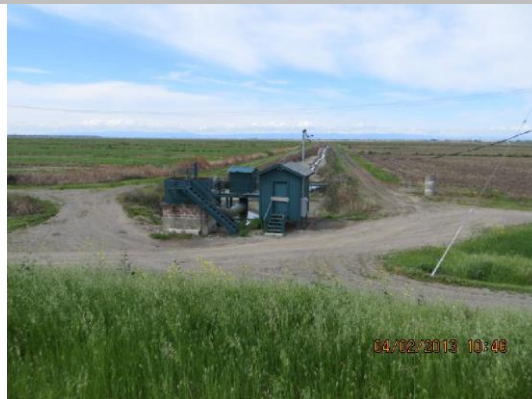
Photo 1 of 2 : UCIP\_FA\_2016\_50171\_18202.jpg

FS\_ID:50171  
DS\_ID:17822  
EP\_NO: N/A  
Repair Type: Urgent  
Crossing Status: Found  
UCIP Comments: 09/14/2016 - Flap gate on the WS was submerged at time of inspection. LS headwall at the pumping plant has exposed rebar. There is still erosion present behind the headwall. However, water was present making it difficult to determine if it is getting worse. As-built drawings were requested from LMA consultant representative. (T. Hatch/UCIP)04/02/2013 - Flap gate broken in half on WS toe. Some erosion at headwalls on pumping plant. (W. Wylie/UCIP) FIELD\_STRUCT\_DESC: 44-inch corrugated metal drainage pipe through the levee, 22 feet below the crown. There is a pump on a platform in a drainage ditch at the toe of the landside (LS) slope. There is a slide gate and flap gates in 5 foot by 9 foot concrete box. There is a flap gate on waterside (WS) toe. There is an 8-inch vent/standpipe at WS toe. [Additional Reference(s): DWR Levee Logs, 1990. USACE Sacramento O&M Manual 121, May 1959 (LM 0.4)].

Pumping plant off LS toe.

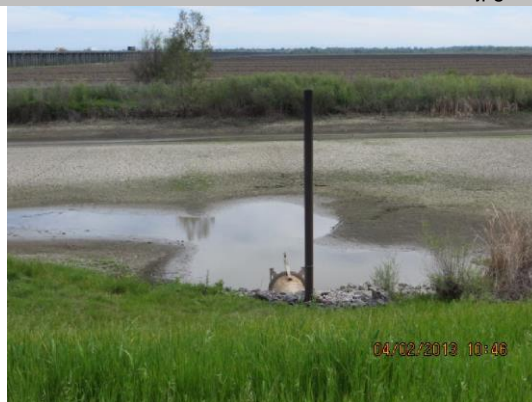
Photo 2 of 2 : UCIP\_FA\_2016\_50171\_18201.jpg

Pipe and flap gate with vent riser on WS toe.

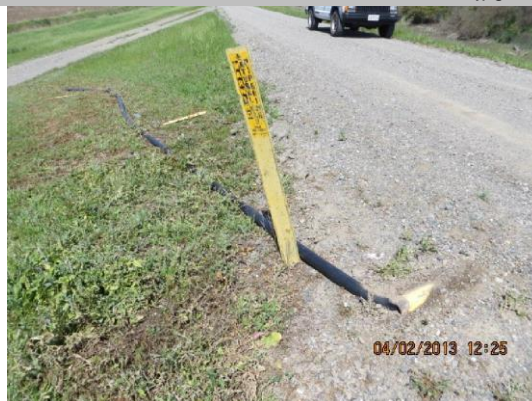
Photo 1 of 2 : UCIP\_FA\_2016\_50090\_18922.jpg

FS\_ID:50090  
DS\_ID:22956  
EP\_NO: N/A  
Repair Type: Non-Urgent  
Crossing Status: Found  
UCIP Comments: 09/14/2016 - Pipe has been removed from the levee and the levee has been repaired. It is unknown if these repairs were done with a permit or if the fill was properly compacted. Gas line markers still on WS shoulder of levee. It is unknown if another gas line exists in this location. (T. Hatch/UCIP)04/02/2013 - Pipe does not have appropriate cover and is marked as gasoline. Does not appear to be a permitted utility. (W. Wylie/UCIP)  
FIELD\_STRUCT\_DESC: \*REMOVED\* 4-inch steel pipe through the levee, 3-inches below the crown. A 2-inch PVC pipe is sleeved through it. No other appurtenances found. Markers along alignment indicate pipe may be a gas line.  
FS Date: 9/14/2016

Pipe crossing with gasline marker on LS shoulder.

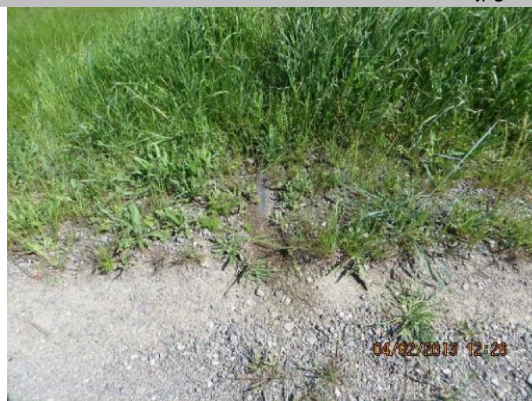
Photo 2 of 2 : UCIP\_FA\_2016\_50090\_18921.jpg

Pipe on WS shoulder.

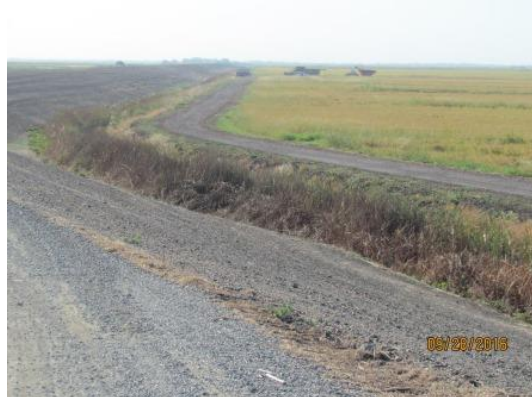
Photo 1 of 1 : FA\_2016\_RD2035\_239\_979\_20160929\_00030.jpg

LM Start	2.18	Rating **	M	Issue No.	979
LM End	4.02	Issue Type +	En	Location *	LS
Category	Earthen Levee			GPS Latitude/Longitude	
				Start	End
Item	Encroachments			38.646063 °	38.623062 °
				-121.666332 °	-121.648925 °
DWR ID	DWR_RD2035_02_s_2012_979				
Comment Code					
DT : Ditch					
Inspector Comment					
Ditch is at the landside toe of the levee.

View of the ditch on the landward side of the levee looking downstream. Fall 2016.

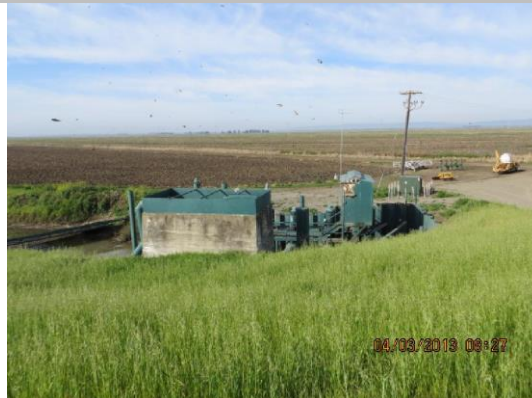
Photo 1 of 2 : UCIP\_FA\_2016\_11526\_18935.jpg

LM Start	4.43	Rating **	M	Issue No.	980
LM End	4.43	Issue Type +	En	Location *	WS
Category	Supplemental			GPS Latitude/Longitude	
				Start	End
Item	DWR UCIP Field Study			38.618030 °	38.618030 °
				-121.645192 °	-121.645192 °
DWR ID					
Comment Code					
Inspector Comment					
FS_ID:11526 DS_ID:17828 EP_NO: 1701 Repair Type: Non-Urgent Crossing Status: Found UCIP Comments: Animal activity at outlet causing damage to berm and undermining the pipe at the outlet headwall on WS toe. FIELD_STRUCT_DESC: 60-inch corrugated metal drain pipe through the levee 20.6 feet below the crown encased in 6-inches of reinforced concrete. Slide gate in 7-foot diameter C.M. pipe riser on waterward slope. Pumping plant with 6-pumps/pipes that discharge into a 4-ft by 18-ft surge box on the LS toe. (Permit No. 1701 - R.D. 2035) FS Date: 4/3/2013

Surge box and pumping plant on LS toe.

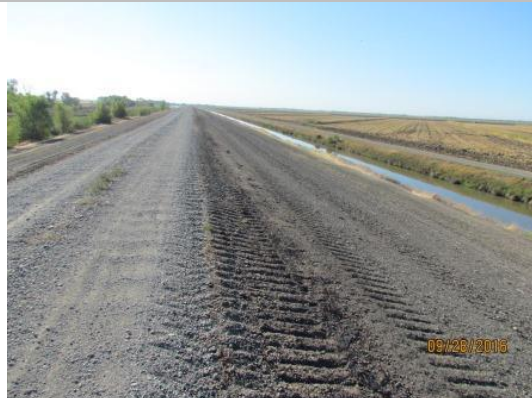
Photo 1 of 1 : FA\_2016\_RD2035\_239\_10\_20161013\_00033.jpg

LM Start	4.43	Rating **	M	Issue No.	10
LM End	6.57	Issue Type +	En	Location *	LS
Category	Earthen Levee			GPS Latitude/Longitude	
				Start	End
Item	Encroachments			38.617921 °	38.589619 °
				-121.645109 °	-121.631277 °
DWR ID	DWR_RD2035_02_s_2013_10				
Comment Code					
DT : Ditch					
Inspector Comment					
Ditch is at the landside levee toe.

View of the drainage ditch on the landward side of the levee looking downstream. Fall 2016.

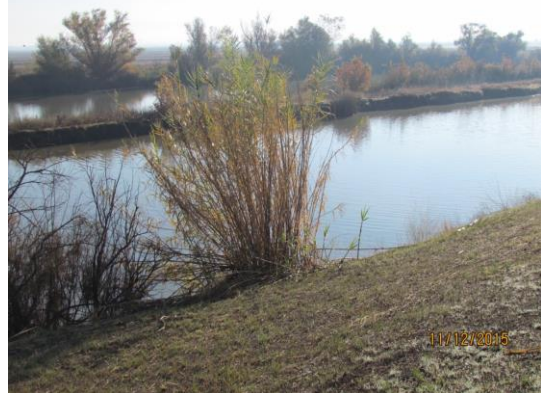
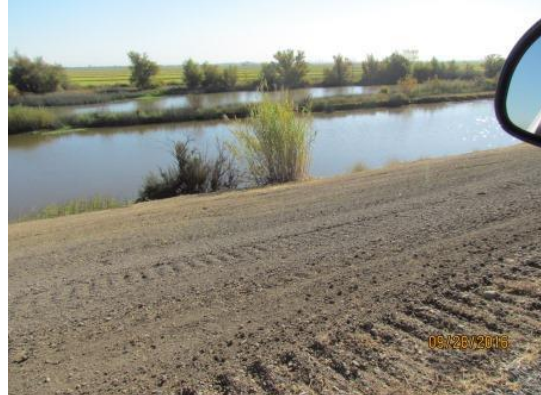
LM Start	5.81	Rating **	A/W	Issue No.	19
LM End	5.81	Issue Type +	Ma	Location *	WS
Category	Earthen Levee			GPS Latitude/Longitude	
				Start	End
Item	Vegetation			38.600462 °	38.600462 °
				-121.632705 °	-121.632705 °
DWR ID	DWR_RD2035_02_f _ 2015_19				
Comment Code					
V2 : Remove the wild growth other than native grasses from the levee slopes.					
Inspector Comment					
Recommend getting rid of arundo.

View of the arundo at the toe of the levee. Fall 2015.

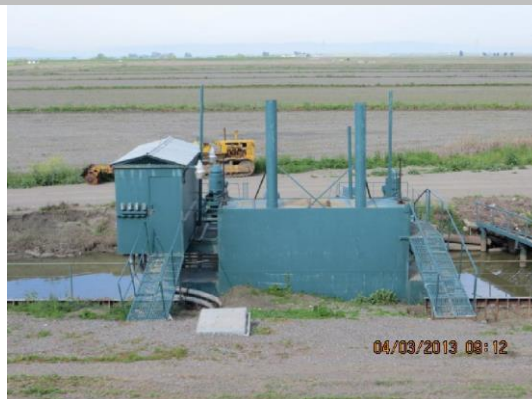
Photo 2 of 2 : UCIP\_FA\_2016\_50088\_18320.jpg

Surge box and pumping plant on LS toe.

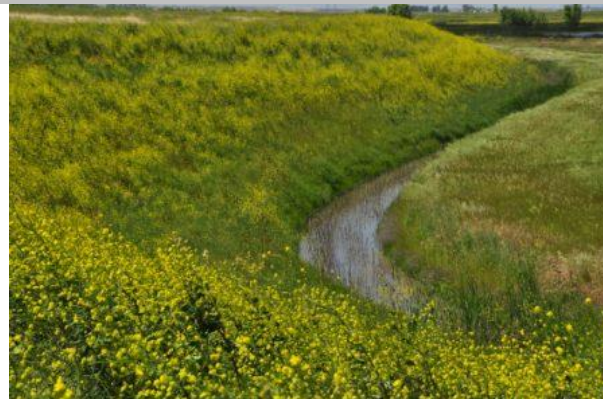
Photo 1 of 2 : FA\_2016\_RD2035\_240\_973\_20160906\_00002.jpg

Landside drainage ditch at levee toe. Spring.

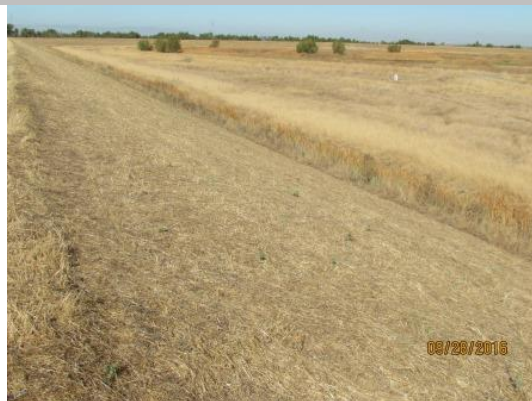
Photo 2 of 2 : FA\_2016\_RD2035\_240\_973\_20160929\_00016.jpg

View of landside ditch at the levee toe looking upstream. Fall 2016.

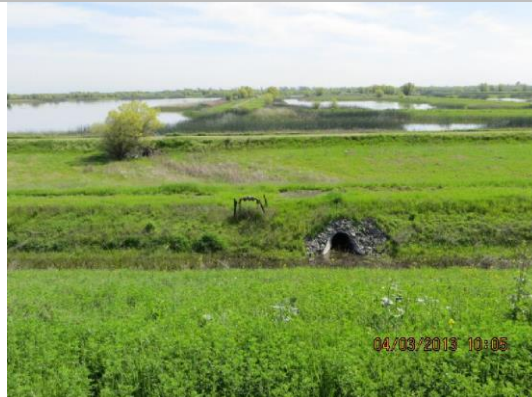
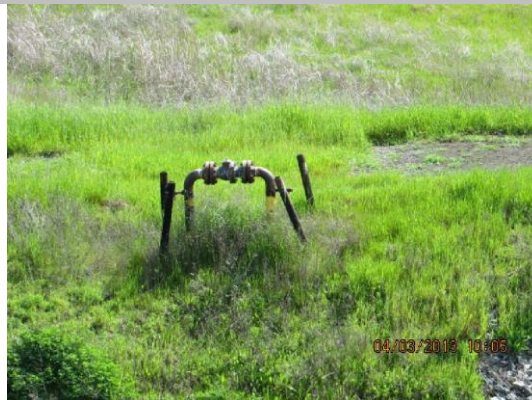
FS\_ID:50078  
DS\_ID:17823  
EP\_NO: 6123  
Repair Type: Urgent  
Crossing Status: Indicator Found  
UCIP Comments: 09/14/2016 - No markers present where the pipe crosses levee. pipe vent appears to indicate alignment parallel to the levee at its visible location. However, permit records indicate pipe does cross the levee approximately 75 feet south from the visible well. (T. Hatch/UCIP)04/03/2013 - Need to install gasoline markers through the levee if pipe is still active. (W. Wylie/UCIP)  
FIELD\_STRUCT\_DESC: 6-inch soil-proofed steel high pressure gas line through the levee, 2.5 feet below the crown. There is a pipe at vent visible off landside (LS) toe. (Permit No. 6123, 1968 - P.G.&E.)  
FS Date: 9/14/2016

Gasline vent off LS toe.

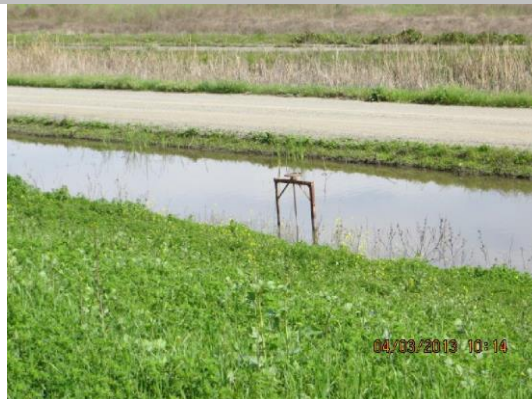
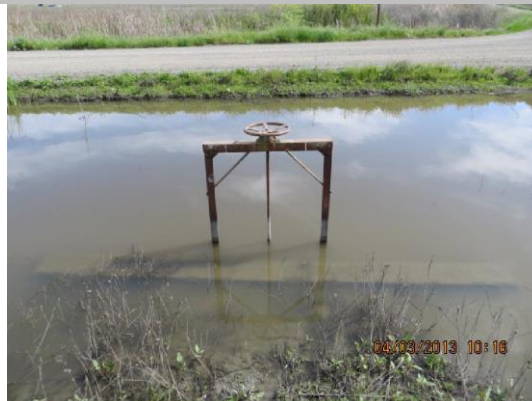
LM Start	1.39	Rating **	M	Issue No.	976
LM End	1.39	Issue Type +	En	Location *	LS
Category	Supplemental			GPS Latitude/Longitude	
				Start	End
Item	DWR UCIP Field Study			38.589425 °	38.589425 °
				-121.645359 °	-121.645359 °
DWR ID					
Comment Code					
Inspector Comment					
FS_ID:41128					
DS_ID:17836					
EP_NO: N/A					
Repair Type: Non-Urgent					
Crossing Status: Found					
UCIP Comments: Need to clear vegetation and debris from WS at outlet.					
FIELD_STRUCT_DESC: 36-inch Corrugated metal pipe through levee 17.5 feet below crown, flap gate on waterward end, slide gate and concrete headwall on landward end. Originally included in O+M manual (1952).					
FS Date: 4/3/2013

Slide gate and headwall in canal at LS toe.

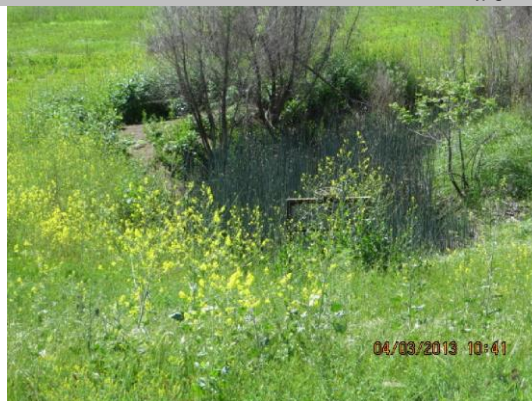
Photo 1 of 2 : UCIP\_FA\_2016\_11011\_18354.jpg

FS\_ID:11011  
DS\_ID:17837  
EP\_NO: N/A  
Repair Type: Non-Urgent  
Crossing Status: Found  
UCIP Comments: Debris and vegetation partially blocking inlet and outlet at both toes.  
FIELD\_STRUCT\_DESC: 48-inch corrugated metal pipe through levee 19.0 feet below crown, slide gate on both ends. Originally included in O+M manual (1952).  
FS Date: 4/3/2013

Slide gate at WS toe showing excessive vegetation.

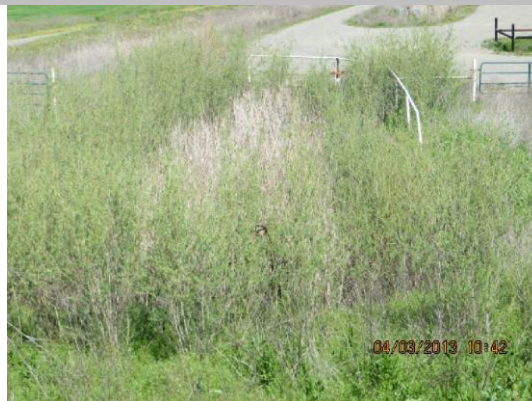
Photo 2 of 2 : UCIP\_FA\_2016\_11011\_18353.jpg

Slide gate at LS toe showing excessive vegetation.

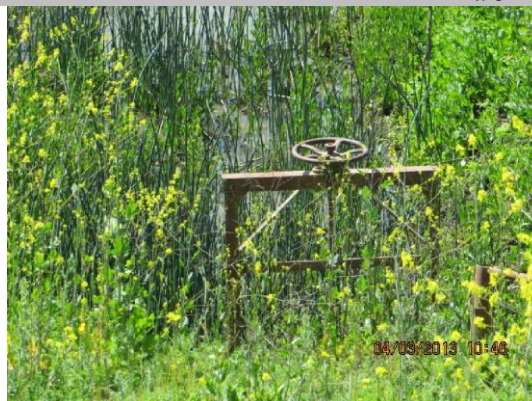
Photo 1 of 2 : UCIP\_FA\_2016\_11012\_18357.jpg

LM Start	2.19	Rating **	M	Issue No.	975
LM End	2.19	Issue Type +	En	Location *	LS
Category	Supplemental			GPS Latitude/Longitude	
				Start	End
Item	DWR UCIP Field Study			38.590909 °	38.590909 °
				-121.659311 °	-121.659311 °
DWR ID					
Comment Code					
Inspector Comment					
FS_ID:11012					
DS_ID:17838					
EP_NO: N/A					
Repair Type: Non-Urgent					
Crossing Status: Found					
UCIP Comments: Debris and vegetation partially blocking both ends of pipe.					
FIELD_STRUCT_DESC: 36-inch pipe through levee 18.0 feet below crown, slide gate on LS toe. Combination flap and slide gate on WS toe. Originally included in O+M manual.					
FS Date: 4/3/2013

Combination flap and slide gate on WS toe. With excessive vegetation

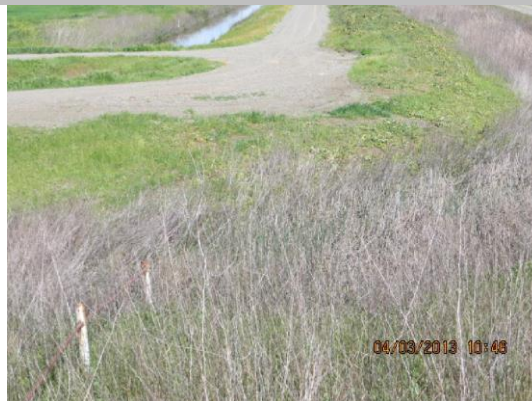
Photo 2 of 2 : UCIP\_FA\_2016\_11012\_18356.jpg

Headwall at bottom of fenceline on LS toe

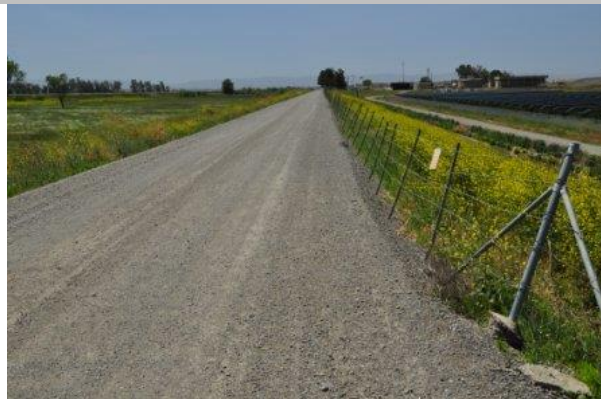
Photo 1 of 1 : FA\_2016\_RD2035\_240\_5\_20160906\_00001.jpg

Fence along the landside shoulder of the crown.
